March 29, 1991
LPC #1178020003 - Macoupin County
Brighton/Brighton Landfill

NARRATIVE

INSPECTION PHOTOS

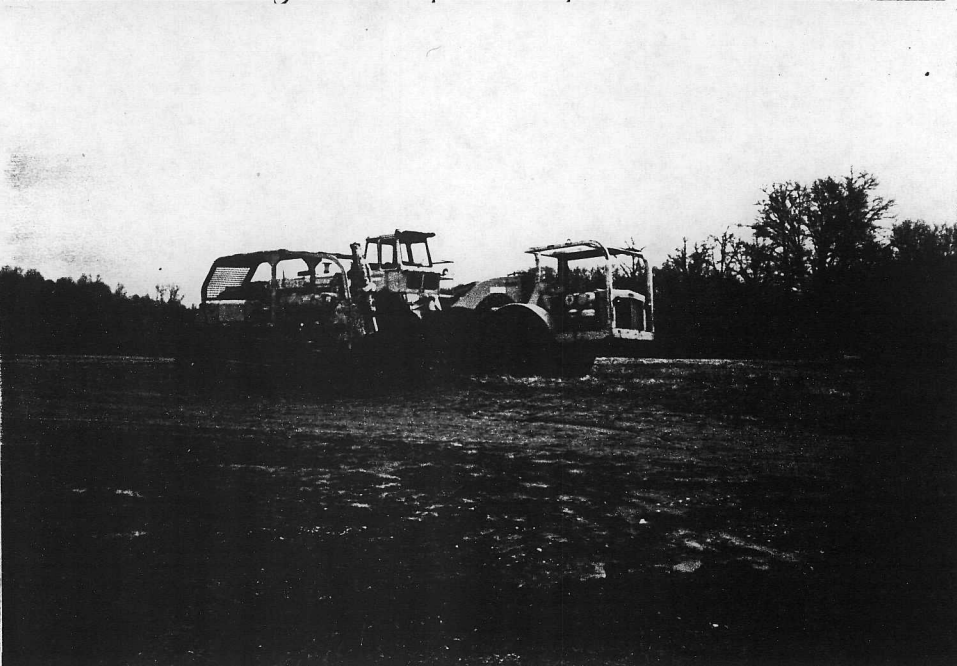
COMMENTS: Pictures taken toward: northeast	
From an area	
east of the	
equipment shed / office -- in the southeast region	
ROLL #: 344 PHOTO #: 1

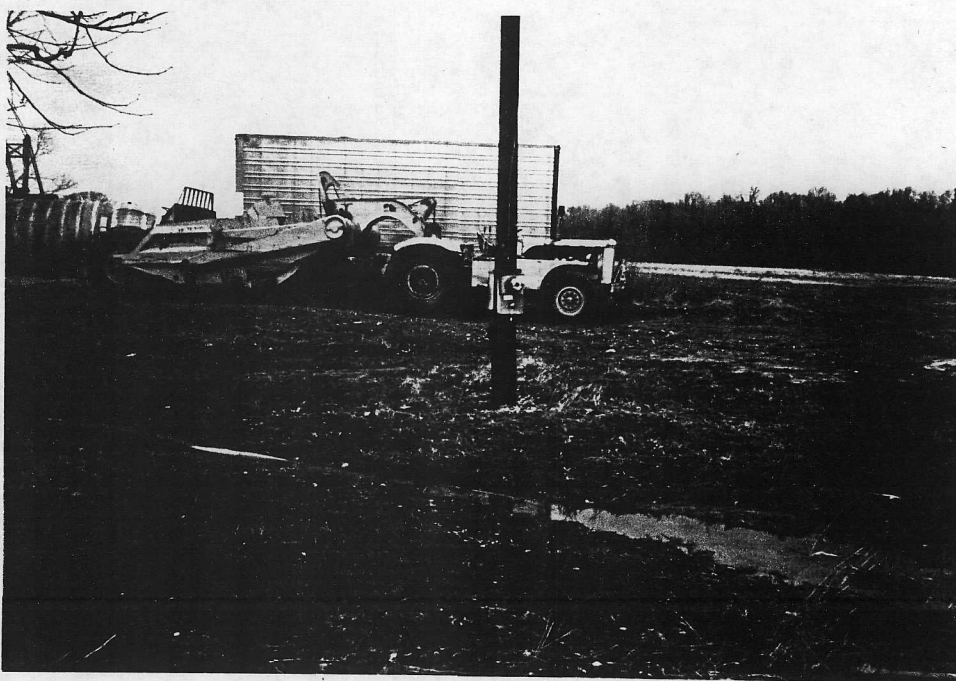
DATE: 03 / 18 / 91
TIME: 8:50AM - 2:15 PM
PHOTOGRAPH TAKEN BY: Rich Johnson
COMMENTS: Pictures taken toward: northwest
From an area
east of the
equipment shed / office -- in the southeast region
ROLL #: 344 PHOTO #: 2

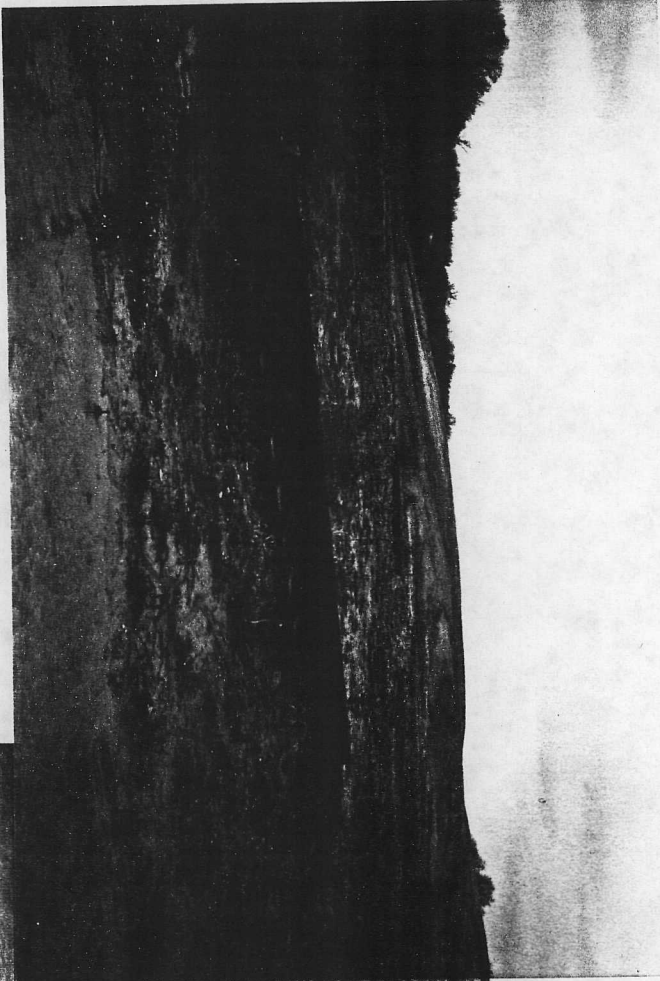
COMMENTS: Pictures taken toward: South west	
from the south- central region of Site 1	
ROLL #: 344 PHOTO #: 3

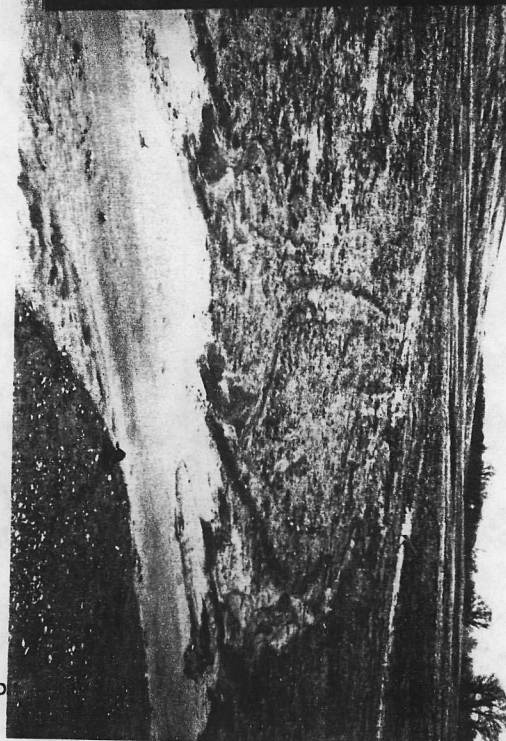
DATE: 03 / 18 / 91
TIME: 8:50AM - 2:15 PM
PHOTOGRAPH TAKEN BY: Rich Johnson
COMMENTS: Pictures taken toward: northwest
From the south- central region of Site 1
ROLL #: 344 PHOTO #: 4

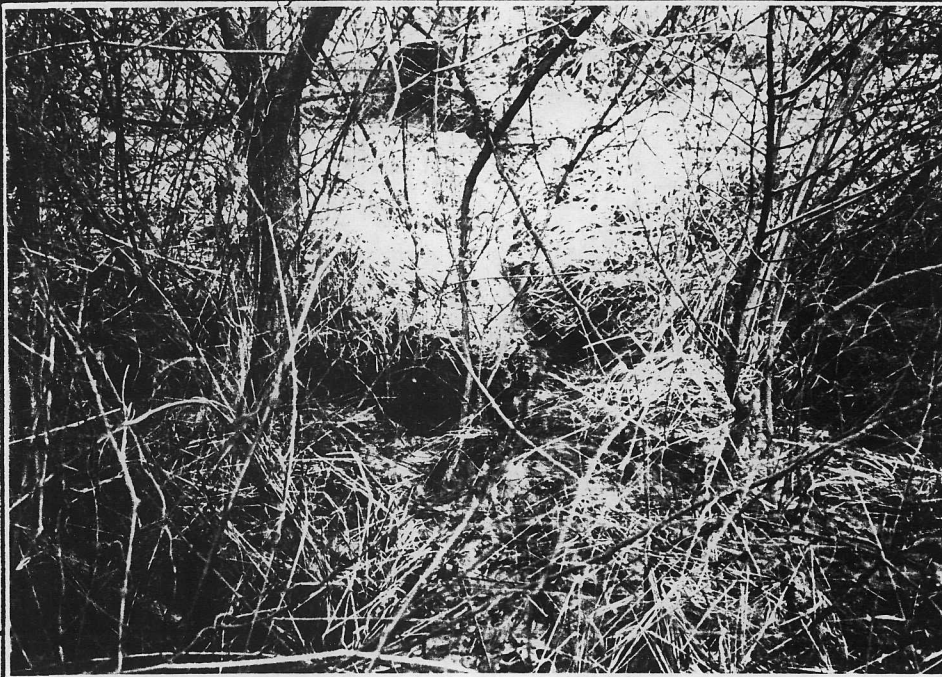
COMMENTS: Pictures taken toward: South from the southwest region of site 1.	
ROLL #: 344 PHOTO #: 5

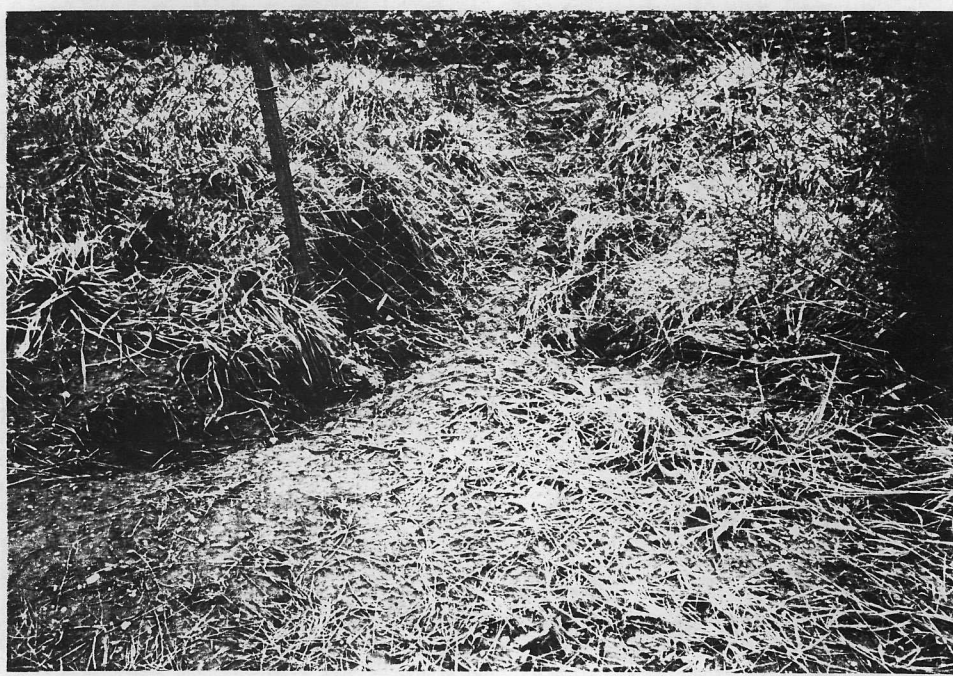
TIME: 8:50AM - 2:15 PM	
PHOTOGRAPH TAKEN BY: Rich Johnson	
COMMENTS: Pictures taken toward: South from the southwest region of site 1.	
ROLL #: 344 PHOTO #: 6

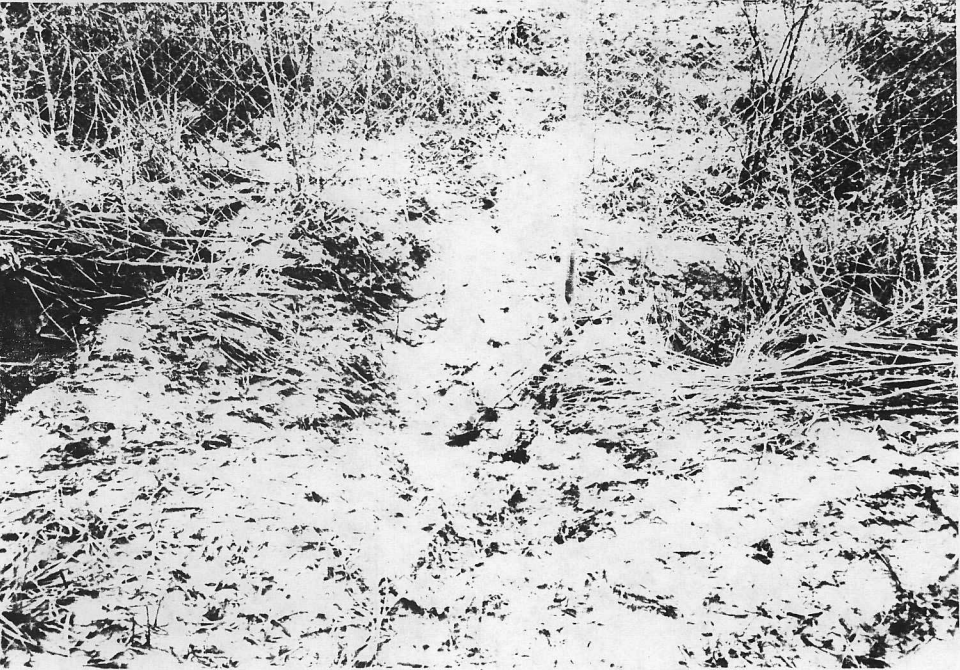
COMMENTS: Pictures taken toward: South from	
the southwest	
region of	
Site 1.	
ROLL #: 344 PHOTO #: 7

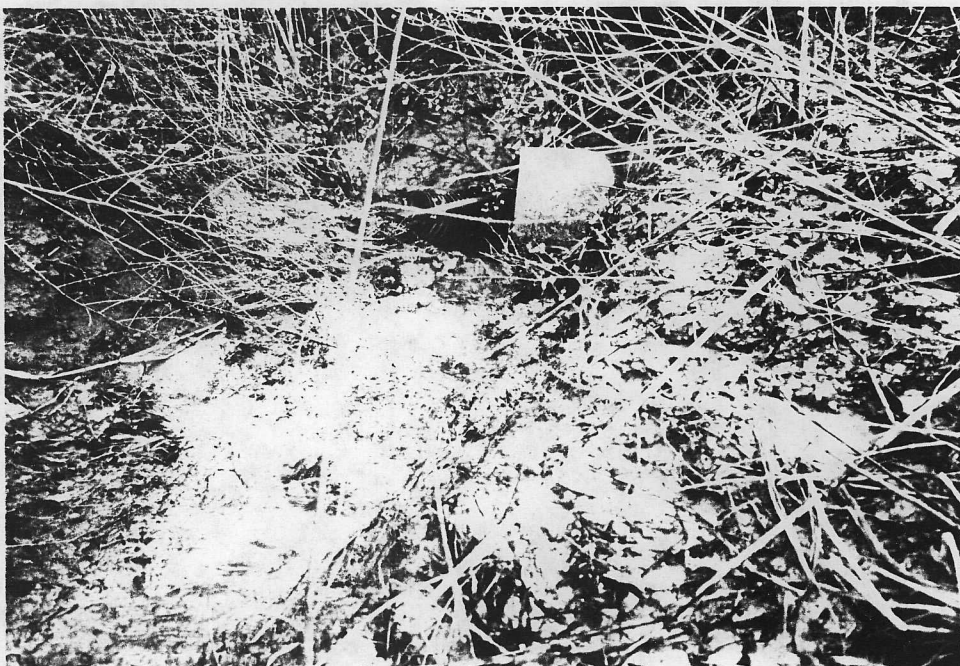
DATE: 03 / 18 / 91
TIME: 8:50AM - 2:15 PM
PHOTOGRAPH TAKEN BY: Rich Johnson
COMMENTS: Pictures taken toward: north east
from the south-
east region
of Site 2
ROLL #: 344 PHOTO #: 8

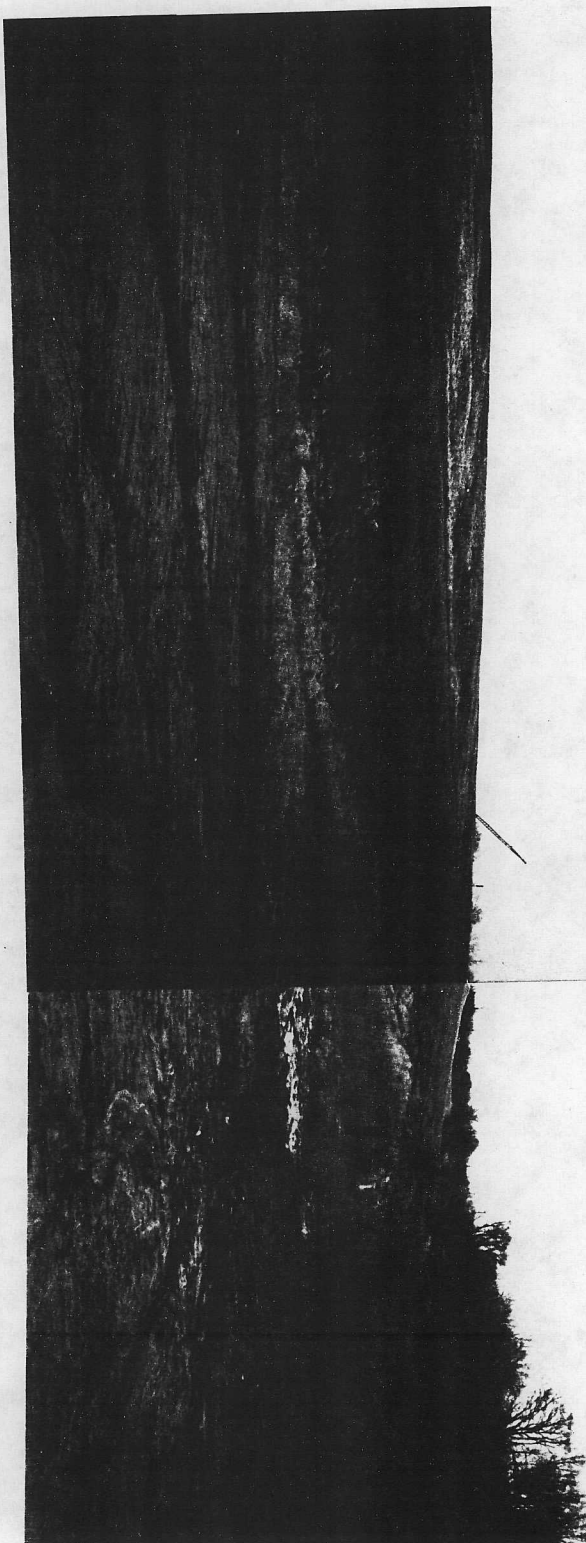
COMMENTS: Pictures taken toward: northeast	
From the south-	
west region	
of site 2.	
ROLL #: 344 PHOTO #: 9

DATE: 03 / 18 / 91
TIME: 8:50AM - 2:15 PM
PHOTOGRAPH TAKEN BY: Rich Johnson
COMMENTS: Pictures taken toward: east from
the southwest
region of site
2.
ROLL #: 344 PHOTO #: 10

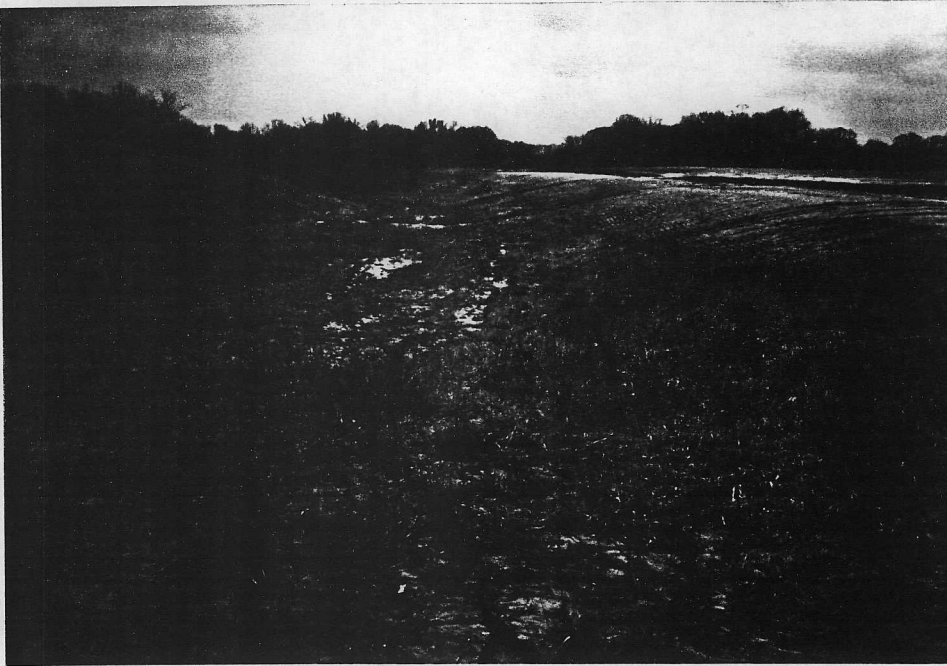
COMMENTS: Pictures taken toward: south from the northwest region of Site 2	
ROLL #: 344 PHOTO #: 11

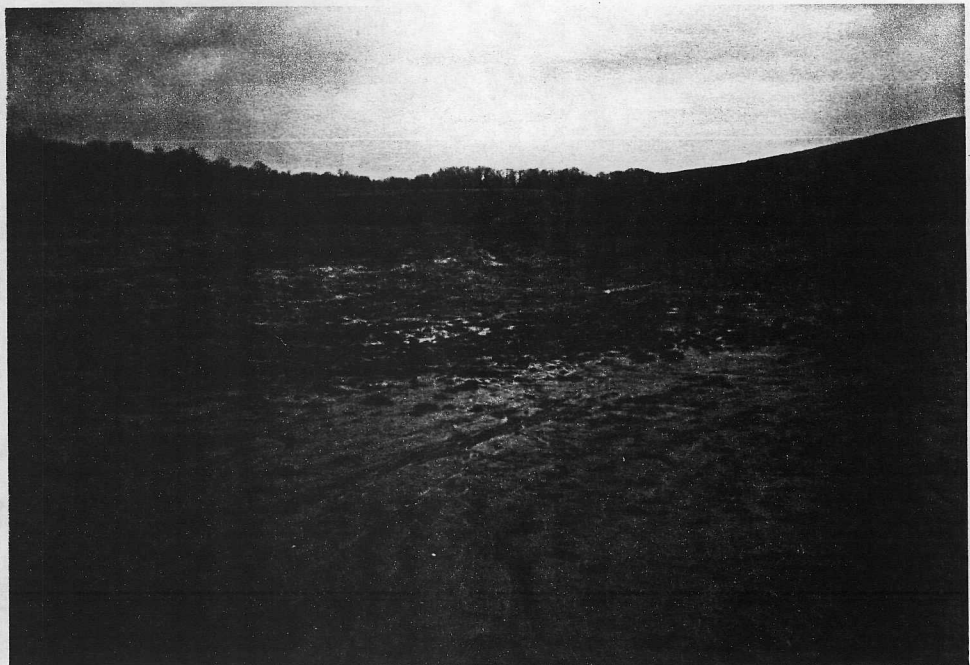
DATE: 03/18/91
TIME: 8:50AM - 2:15 PM
PHOTOGRAPH TAKEN BY: Rich Johnson
COMMENTS: Pictures taken toward: east from an area near the northwest corner of Site 2
ROLL #: 345 PHOTO #: 12

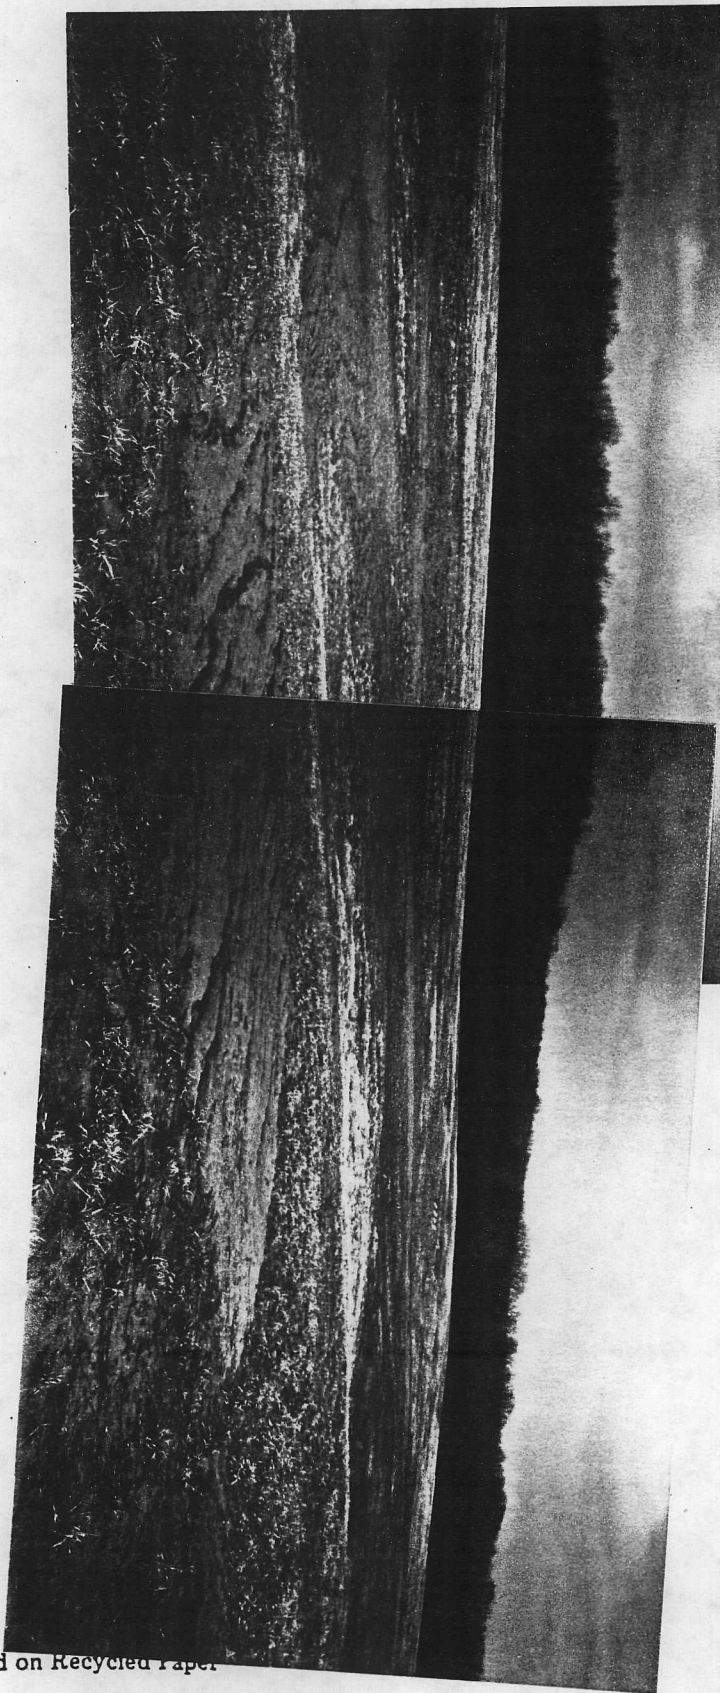
DATE: 03 / 18 / 91	SITE #: 1 1 7 8 0 2 0 0 0 3 CO.: Macoupin
TIME: 8:50AM - 2:15 PM	SITE NAME: Brighton / Brighton Land Fill
PHOTOGRAPH TAKEN BY: Rich Johnson	
COMMENTS: Pictures taken toward: northeast from the north- east region of Site 2	
ROLL #: 345 PHOTO #: 13

DATE: 03 / 18 / 91
TIME: 8:50AM - 2:15 PM
PHOTOGRAPH TAKEN BY: Rich Johnson
COMMENTS: Pictures taken toward: northeast from the northeast region of Site 2
ROLL #: 345 PHOTO #: 14

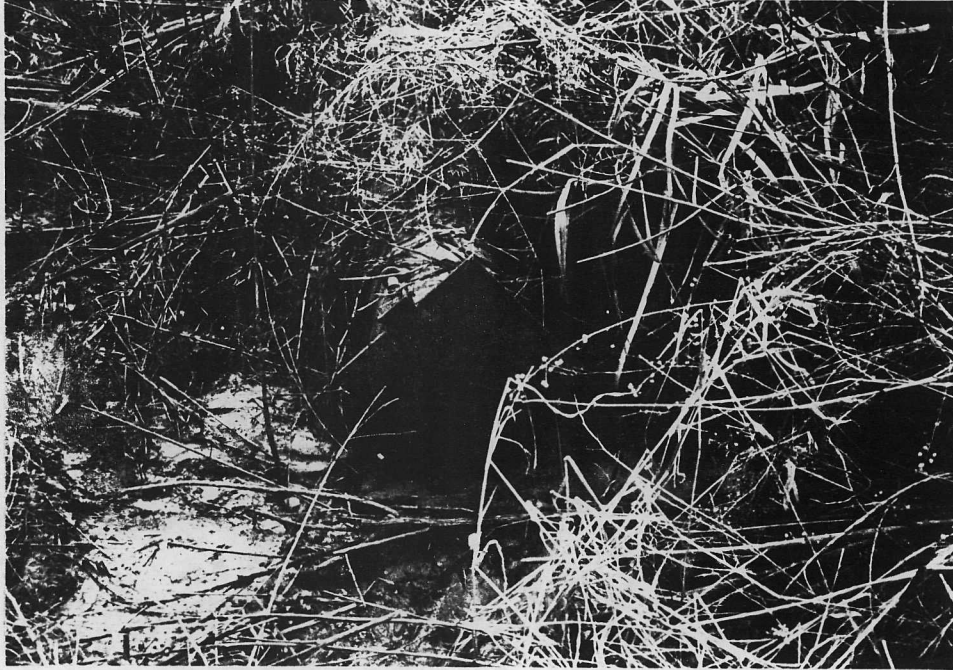
COMMENTS: Pictures taken toward:	
South From	
north of the	
northeast corner of Site 2.	
ROLL #: 345 PHOTO #: 15

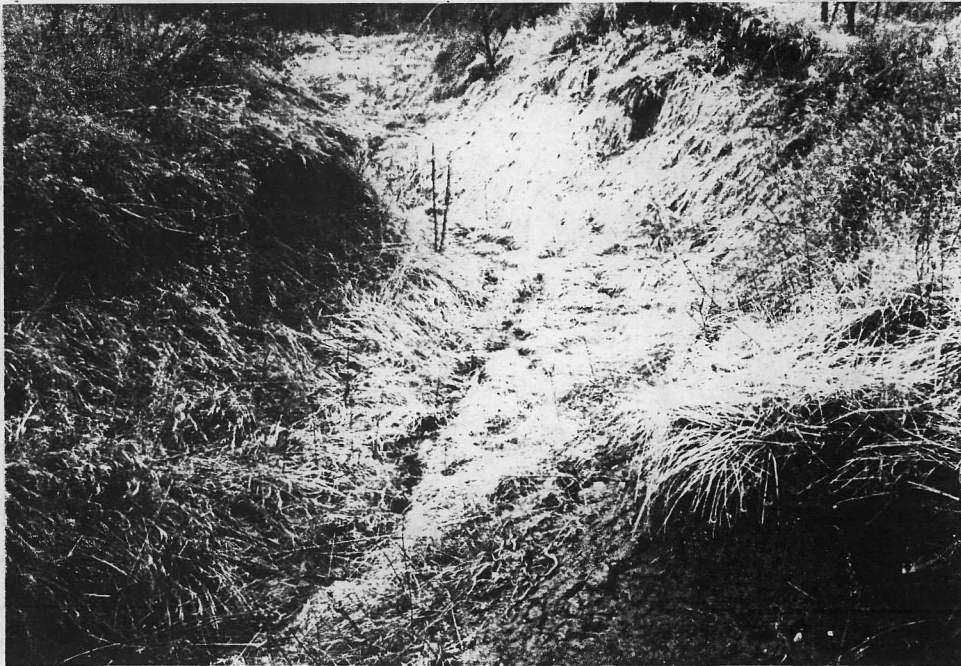
TIME: 8:50AM - 2:15 PM	
PHOTOGRAPH TAKEN BY: Rich Johnson	
COMMENTS: Pictures taken toward:	
northwest from the north- west region of Site 1.	
ROLL #: 345 PHOTO #: 16

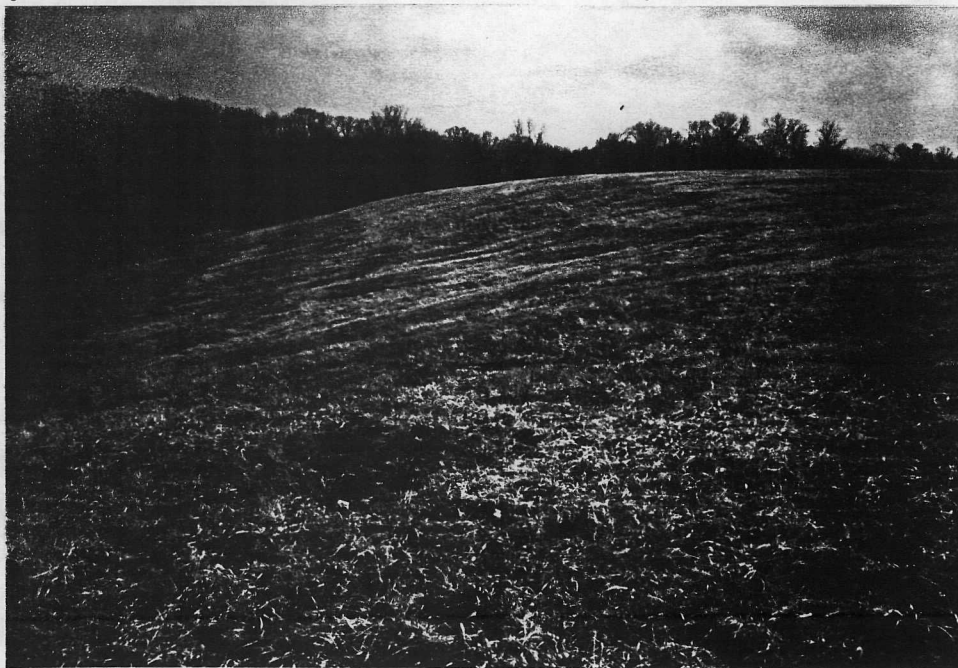
DATE: 03/18/91
TIME: 8:50AM - 2:15 PM
PHOTOGRAPH TAKEN BY: Rich Johnson
COMMENTS: Pictures taken toward: Southeast
from the northwest region of Site 1.
ROLL #: 345 PHOTO #: 18
